## Study and Assessment of Ground Failures and Landslides Along the Mountain Roads in the Al-Hamra and Al-Labib Areas of the Western Mountain, Libya

### ABSTRACT

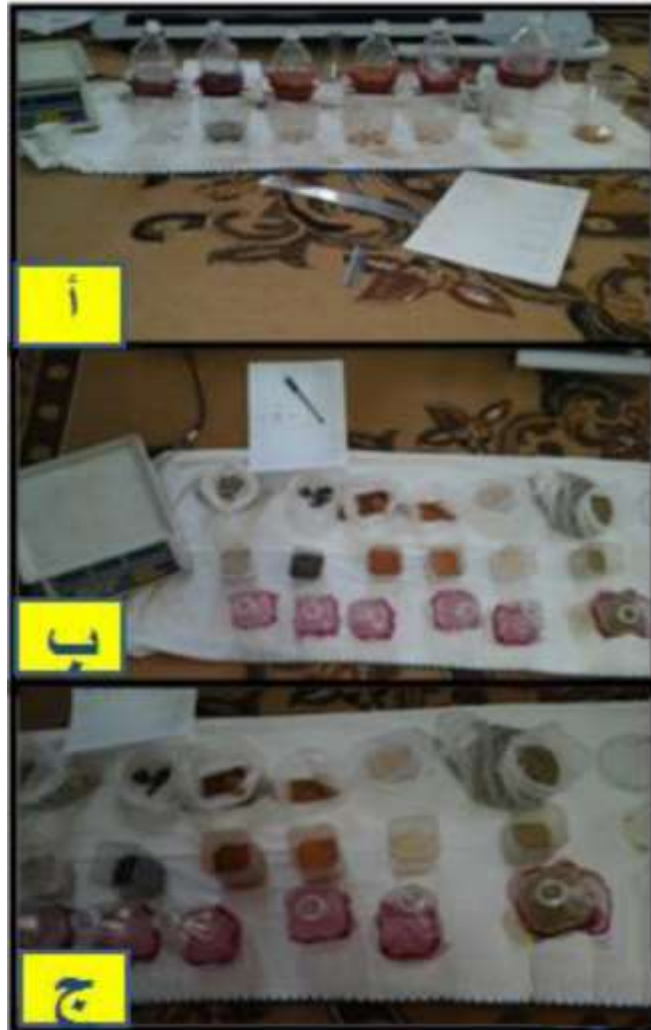
Figure (3 - A, B, C): Shows the equipment and tools used by the researcher to estimate permeability.

1. The lower end of the sample container was covered with a piece of suitable filter cloth or No. 200 sieve mesh to prevent the loss of fine particles while allowing water to pass freely through the sample.
2. The sample cylinder was placed inside the main reservoir of the apparatus and covered from above with a lid containing an opening through which water could enter.
3. The upper reservoir was completely filled with water. A constant hydraulic head difference between the water level at the inlet and the outlet was maintained by opening a valve that allowed excess water to discharge from the system.

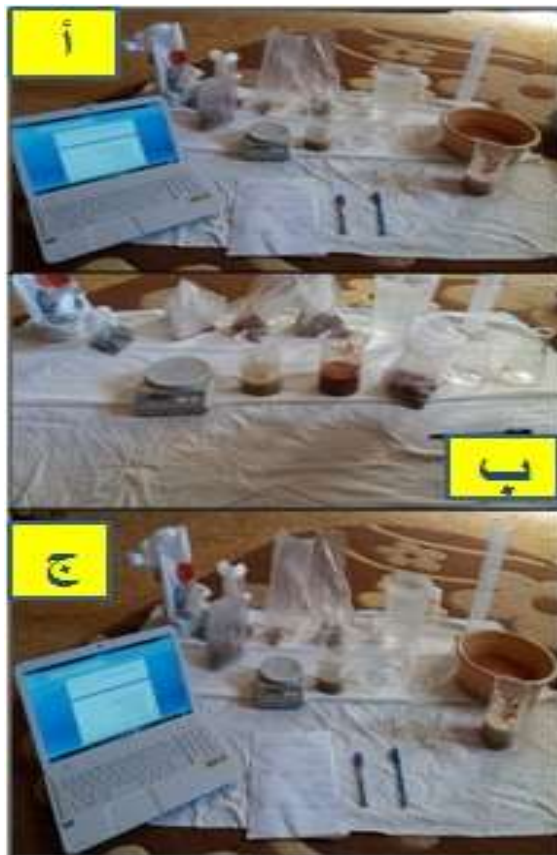
Figure (4 - A, B, C): Shows the equipment used to measure the porosity of the samples collected from the study area.

The equipment used in the experiment is presented in Figure (4 - a, b, and c).

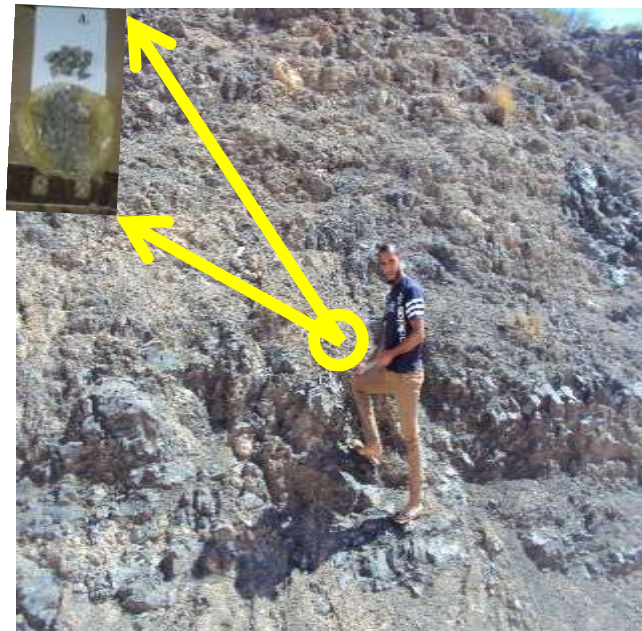
Figure (6) shows an exposure of the Yefren Marl Member, which represents one of the members of the Sidi Al-Siad Formation. The member consists predominantly of multicolored marl, including dark-gray marl, as shown in figure (6 and 7). The marl is interbedded with layers of shale, limestone, and dolomite.

Figure (6): Shows a section of the first site, which is part of the Sidi Al-Siad Formation. This section represents the area preceding the part that was affected by a landslide.

This part of the exposure represents the initial stage of the ground failure, as it occurs immediately before the more pronounced zones affected by landsliding and ground collapse. A representative sample was collected from this location and assigned the code (1), as shown in **figure (5)**. In contrast, another exposed section of the Yefren Marl Member above the mountain road in the Al-Hamra area has undergone a **forward landslide**. As shown in **figure (7 c)**, soil material from the upper part of the formation has moved downward and accumulated in the lower part of the exposure, where a progressive increase in displaced material can be observed.

In the first site in the Al-Hamra area, which represents the Yefren Marl Member of the Sidi Al-Siad Formation and contains interbeds of shale, limestone, and dolomite, the field observations indicate the development of an initial ground-failure zone. Other exposed parts of the Yefren Marl Member along the upper section of the mountain road experienced landsliding and ground failure across the exposed section. A portion of the formation became separated into front and rear blocks, and the observed movement was classified as a rapid landslide.

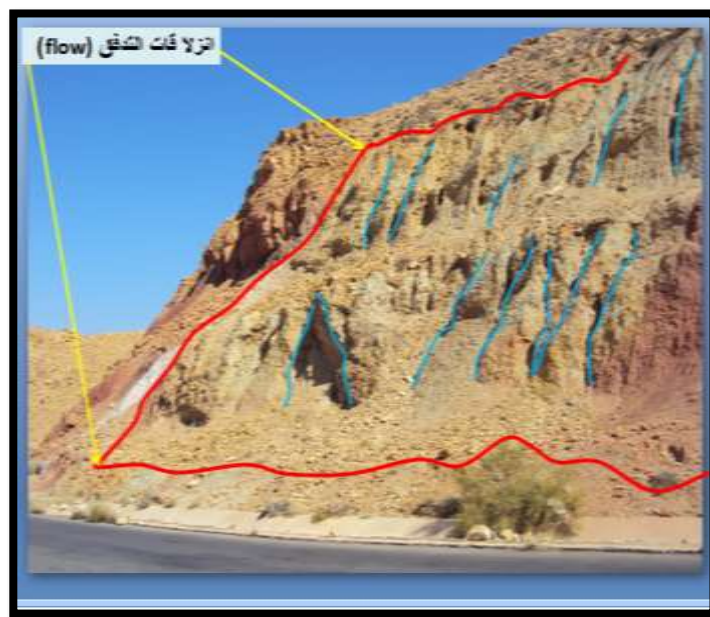
Another part of the site represents an exposed section of the Kursh Formation characterized by green-colored clay-rich material with a fine texture, interbedded with pink and reddish-brown material containing white speckles. The green coloration may reflect the mineralogical composition and depositional or post-depositional conditions of the sediments. The observed landslide also exhibits significant internal mixing of particles during movement. Material from

the upper part of the slide becomes incorporated into the lower part, while material from the lower part may also be displaced upward and mixed with the overlying material. This type of movement, characterized by considerable internal deformation and mixing of the displaced material, is classified as a flow-type landslide (flow), as illustrated in figure (9). A representative sample was collected from this location and assigned the sample codes (4, 6, and 7), as shown in figure (5).

Figure (9): Shows the flow-type landslides present at the second site in the Al-Hamra area, which occur as a result of the mixing of particles accompanied by movement.

In another exposed section of the same formation, the observed landslide was characterized by substantial mixing and internal deformation of particles during movement, with material being displaced and incorporated

from the upper to the lower parts of the slide and vice versa. Based on these characteristics, the observed movement was classified as a flow-type landslide (flow).

Appropriate reinforced-concrete retaining or protective structures should be considered at the upper and/or vulnerable parts of exposed sections affected by flow-type landslides and in the vicinity of very steep slopes. These areas may be susceptible to sudden failure, which could pose significant risks to road users and result in material damage.

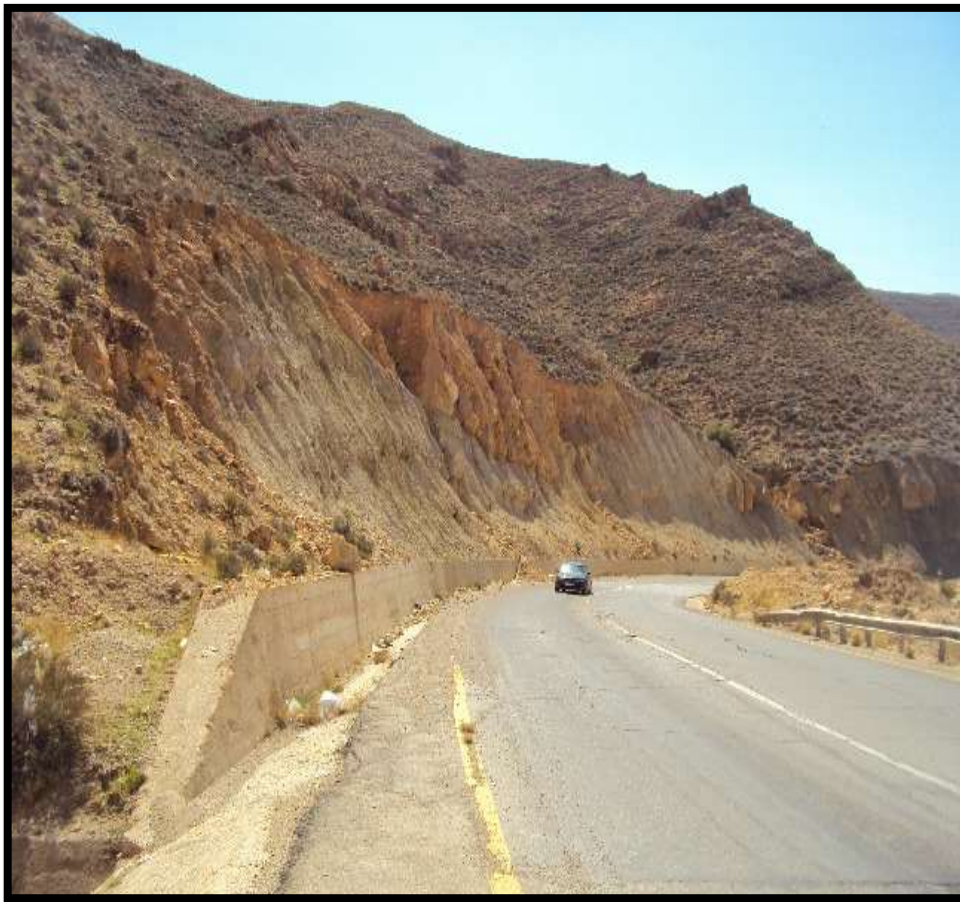
Figure (10): Shows the flow-type landslides present at the second site in the Al-Hamra area, which occur as a result of the mixing of particles accompanied by movement.

The Al-Labib area is located north of Al-Asabaa City. A mountainous road connecting the city with the areas of the inner mountain, beginning near the towns of Al-Rabta, crosses the Al-Labib area, as shown in figure (10). During the design and construction of the road, several road cuts were created along its margins. These cuts exposed parts of the geological formations and increased the visibility of the rock units in the area.

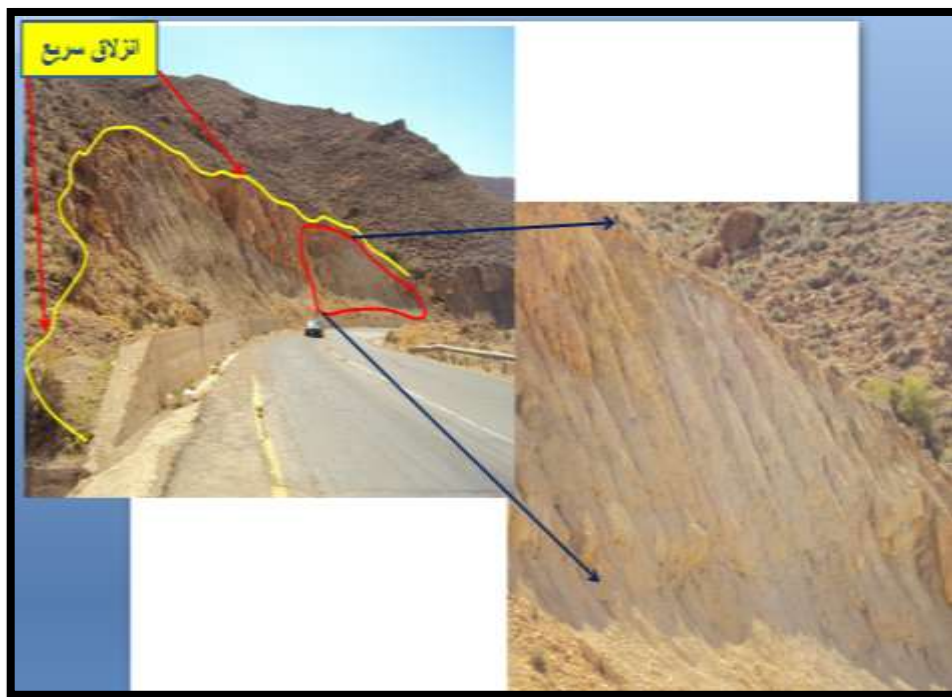
This site is located within a relatively steeply inclined section of the mountain road, near the beginning of the first road bend. On the western side of the road, the outer layer of the exposed section has undergone surface failure, as shown in figure (11). The affected section represents the upper part of the Aboshaba Formation, which is characterized by relatively high porosity and permeability and may therefore possess favorable reservoir characteristics. During rainfall events, the upper part of the exposure may become saturated as a result of the accumulation and infiltration of rainwater. Because the section has a steep slope, increased water saturation may reduce the stability of the weathered or loosened surface material and contribute to its failure.

Figure (11): Shows the landslide at the first site in the Al-Labib area.

This phenomenon can therefore be classified as a rapid ground failure. The green and light-brown colors observed in the exposure are consistent with the occurrence of red and green clay-rich sediments within the upper part of the Aboshaba Formation. A representative sample was collected from this site and assigned the sample codes (8 and 9), as shown in figure (5).

At the first site, surface failure followed by downslope movement was observed. The upper part of the exposure became saturated with rainfall, which contributed to the separation and subsequent gradual failure of part of the exposed material. Based on the observed behavior, this failure was classified as a rapid to moderately rapid movement.

Protective wire meshes and suitable rockfall-control systems should be installed on exposed sections that have experienced landslides or ground failures, particularly in areas with moderate or gradual slopes. Such measures can improve the stability of the exposed surface and reduce the movement and downslope rolling of loose rock fragments and blocks onto the roadway under the influence of gravity.

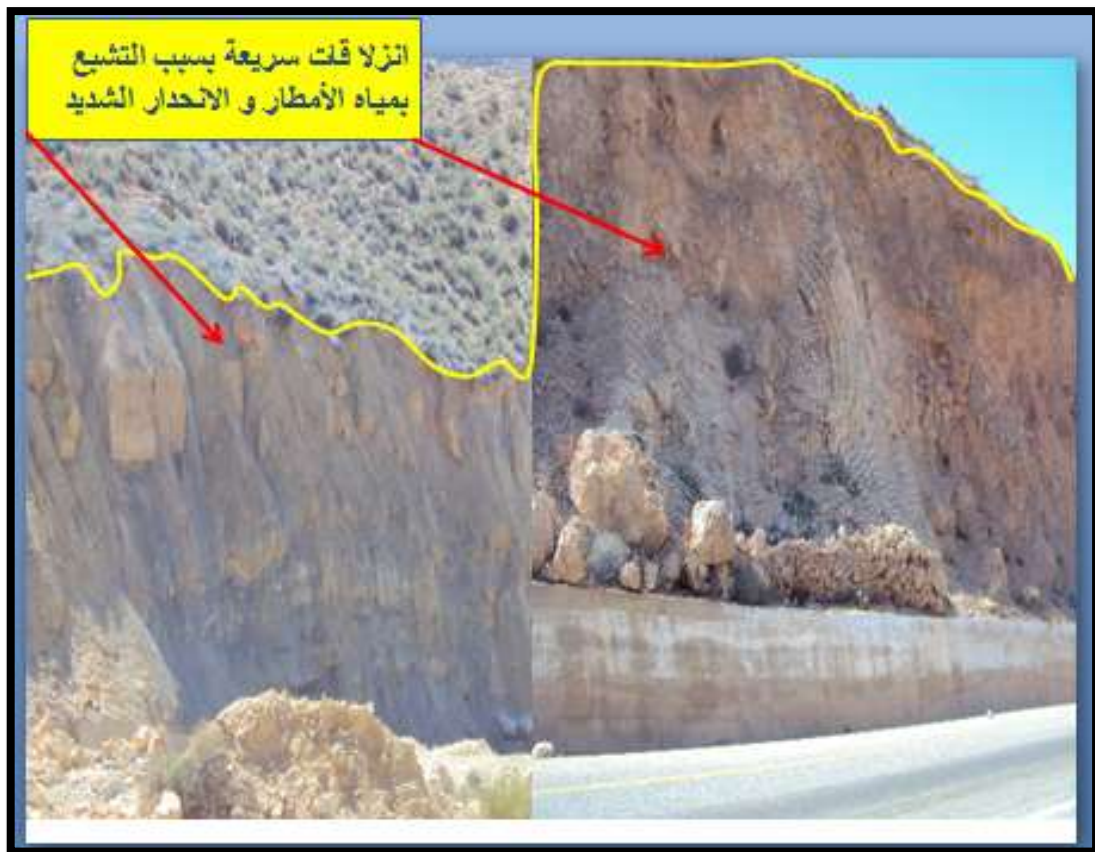
This site represents an exposed section of the Aboshaba Formation in the Al-Labib area. The exposure is characterized by a very steep slope, with an inclination exceeding approximately  $80^\circ$ . The Aboshaba Formation consists predominantly of sandstone characterized by relatively high porosity and permeability. At this site, the sandstone displays a yellow coloration with light reddish-brown staining, which is attributed to the presence of iron oxides, particularly hematite. A significant amount of breccia is also observed within the exposure. Coarse fragments occur within finer-grained rock material, producing a heterogeneous texture that may increase the effective pore space and permeability of parts of the section. Consequently, rainfall infiltration and water saturation may occur relatively rapidly. Under conditions of high water saturation and steep slope inclination, the stability of the exposed material may be reduced, resulting in sudden failure of the frontal part of the section.

Figure (12): Shows the second site in the Al-Labib area, illustrating the rapid ground failure caused by the steep slope.

The observed movement is interpreted as a subsidence-type ground failure, in which the displacement is predominantly vertical rather than parallel to the slope. Partial saturation of the formation may contribute to

At the second site, the ground failure occurred within a very steeply inclined section. The observed movement was classified as subsidence, characterized predominantly by vertical displacement along the exposed section. The combination of steep slope inclination, rainfall infiltration, and the physical properties of the sandstone may have contributed to the development of this type of ground failure.

Road authorities and specialized engineering companies should evaluate the possibility of modifying or locally rerouting sections of the road in both study areas, particularly where the road crosses very steep slopes and geological formations characterized by relatively high porosity and permeability. Such locations may be susceptible to different types of ground failure, particularly rapid and sudden failures.
